Manhole Inspection Summary

Manhole # S27AA_016MH

Location Address: **716 FREMONT AVE**

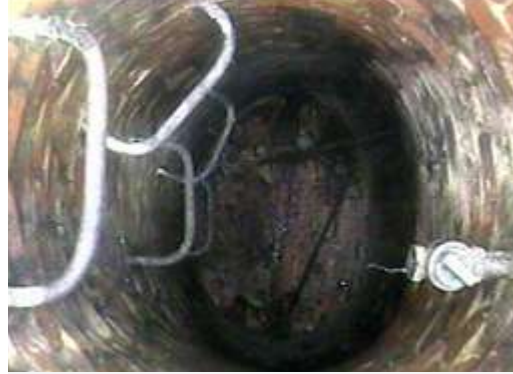
Top View

Comments **POSSIBLE ILLICIT CONNECTION @ 3 O'CLOCK - SEE TOP VIEW PHOTO**

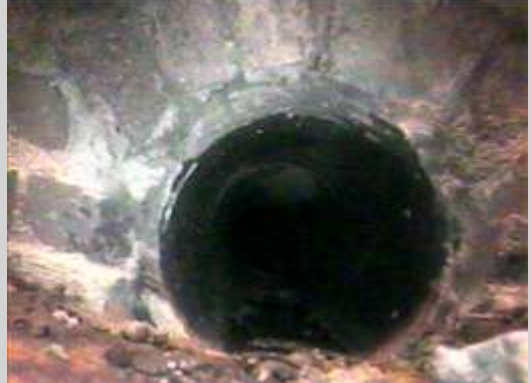
12 O'Clock Outflow

8 in. Circular Gravity Sewer
Pipe Out @ 12 O'Clock

Infiltration: **None** Pipe Seal Cond: **Sound**

☒ **Possible Illicit Connection**
